Manhole Inspection Summary

Manhole # S31UU_023MH

Location Address: **2926 FOX ST**

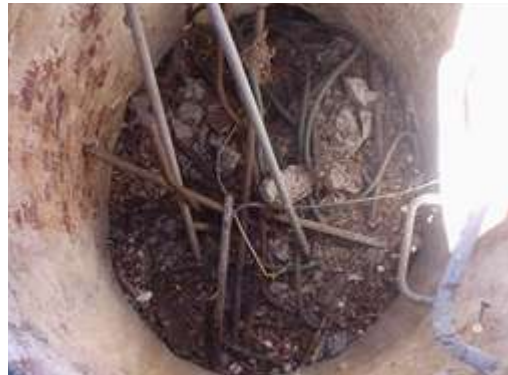
Top View

Channel debris.

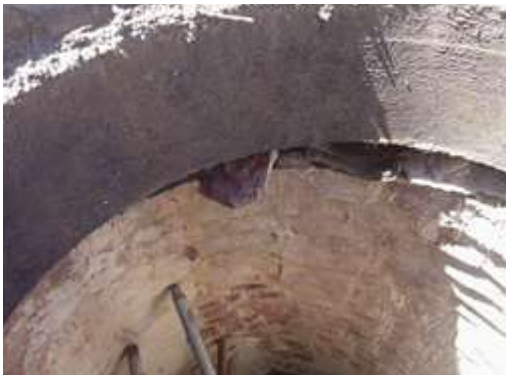
Defect

Frame leaks. Adjustment deterioration, loose brick and infiltration.

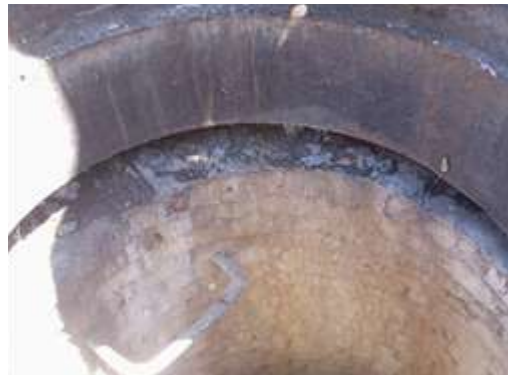
Defect

Frame leaks. Adjustment deterioration and infiltration.

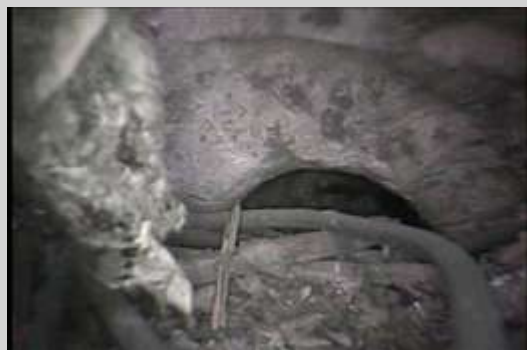
Pipe Out @ 12 O'Clock

Deposits: ☐ None ☒ **Mud** ☐ Sludge ☒ **Debris** ☐ Grease

Silt Depth: **6** (in.)

Deposits Extent: **Heavy**
